Subarunet Announcement

UPDATE: Subaru Safety Recall WTV-81 EPB Actuator Assembly

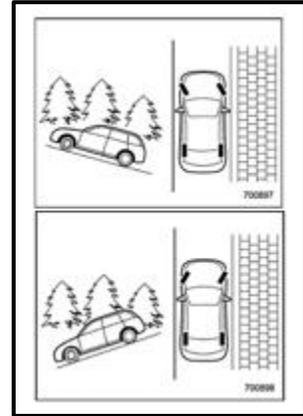
- Whenever possible, park the vehicle in a flat location.
- When parking uphill, the front wheels should be turned away from the curb as shown. Also, be sure to shift the M/T shifter into first gear when parking uphill.
- When parking downhill, the front wheels should be turned into the curb as shown. Also, be sure to shift the M/T shift lever into reverse gear when parking the vehicle downhill.
- Apply the electronic parking brake (EPB) by depressing the brake pedal and pressing the parking brake switch firmly.
